**Flood Control Project Maintenance
Levee Inspections**

Fall 2015 Levee Maintenance Deficiency Summary Report

San Joaquin River Basin

Reclamation District No. 2085 Kasson

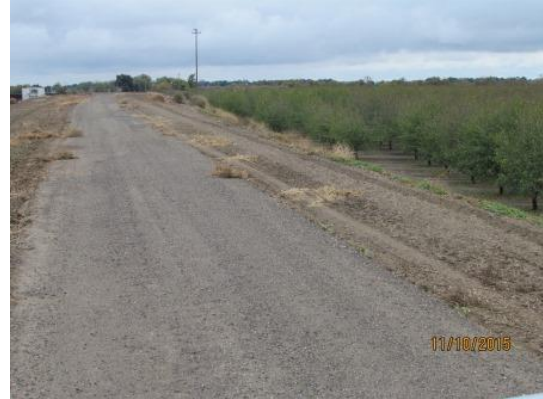
Photo 1 of 1 : FA_2015_RD2085_113_19_20151112_00019.jpg

View of the diskings on the levee crown shoulder.

LM Start	0.53	Rating **	M	Issue No.	55
LM End	0.53	Issue Type +	En	Location *	CR
Category	Supplemental			GPS Latitude/Longitude	
				Start	End
Item	DWR UCIP Field Study			37.723415 °	37.723415 °
				-121.298596 °	-121.298596 °
DWR ID					
Action/Comments					
Inspector Comments: FS_ID:41350					
DS_ID:20677					
EP_NO: N/A					
FS_HLM: 0.473					
Repair Type: Non-Urgent					
Crossing Status: Found					
UCIP Comments: Pipe abandoned. Erosion around pipe on WS slope.					
Pipe severely corroded. Pier badly damaged.					
FIELD_STRUCT_DESC: 14-inch steel stormdrain pipe through the					
levee 4.5 feet below crown. Pump on pile structure in ditch on the					
landward side. Siphon breaker in corrugated metal riser unit on the					
waterward shoulder. Originally included in the 1968 O&M manual.					
FS Date: 09/05/2013

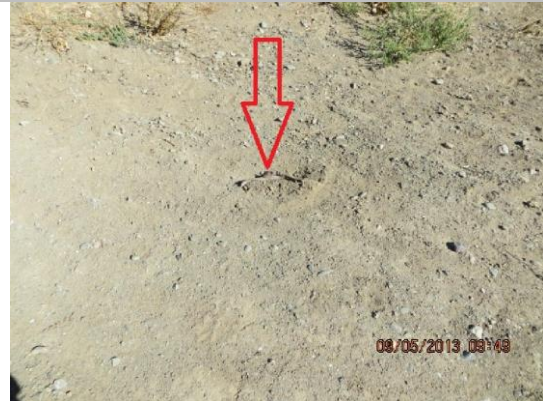
Photo 1 of 3 : UCIP_FA_2015_4399.jpg

Siphon breaker in 24-inch CMP riser on WS shoulder. Filled with soil.

Inspector Comments: FS_ID:41350
 DS_ID:20677
 EP_NO: N/A
 FS_HLM: 0.473
 Repair Type: Non-Urgent
 Crossing Status: Found
 UCIP Comments: Pipe abandoned. Erosion around pipe on WS slope.
 Pipe severely corroded. Pier badly damaged.
 FIELD_STRUCT_DESC: 14-inch steel stormdrain pipe through the levee 4.5 feet below crown. Pump on pile structure in ditch on the landward side. Siphon breaker in corrugated metal riser unit on the waterward shoulder. Originally included in the 1968 O&M manual.
 FS Date: 09/05/2013

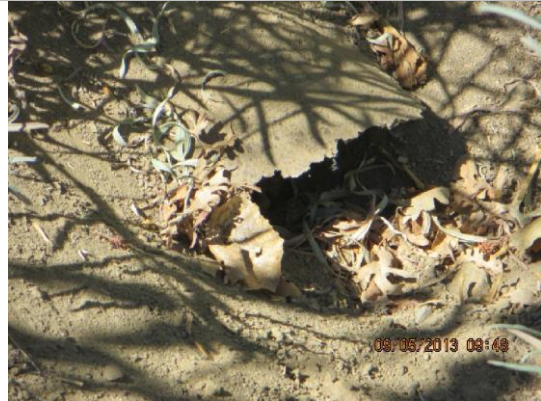
Photo 2 of 3 : UCIP_FA_2015_4400.jpg

Pipe at WS toe.

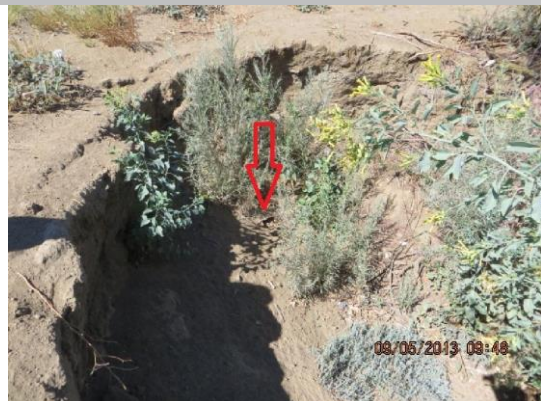
Photo 3 of 3 : UCIP_FA_2015_4401.jpg

Pipe on WS with erosion into levee slope.

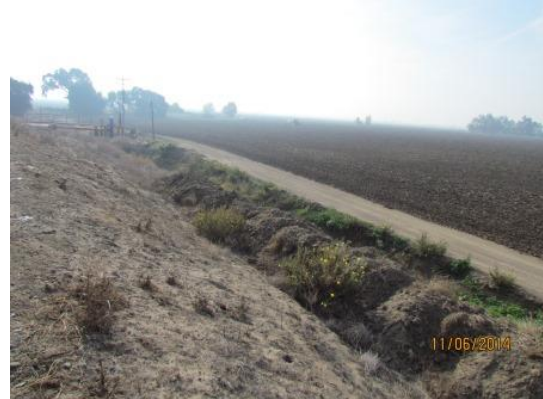
Photo 1 of 1 : FA_2015_RD2085_113_6_20150910_00003.jpg

View of the ditch at the landside levee toe.

LM Start	1.35	Rating **	M	Issue No.	56
LM End	1.35	Issue Type +	En	Location *	LS
Category	Supplemental			GPS Latitude/Longitude	
				Start	End
Item	DWR UCIP Field Study			37.714404 °	37.714404 °
				-121.289469 °	-121.289469 °
DWR ID					
Action/Comments					
Inspector Comments: FS_ID:22285 DS_ID:24055 EP_NO: N/A FS_HLM: 1.289 Repair Type: Non-Urgent Crossing Status: Found UCIP Comments: No permit identified for this modified crossing. FIELD_STRUCT_DESC: 12-inch steel pipe through the levee 3-feet below the crown. Pump mounted on pile structure in ditch on the landward side. Siphon breaker in 12-inch steel riser unit and a gatevalve on the waterward shoulder. (Permit No. 8189, 1972) FS Date: 09/10/2013

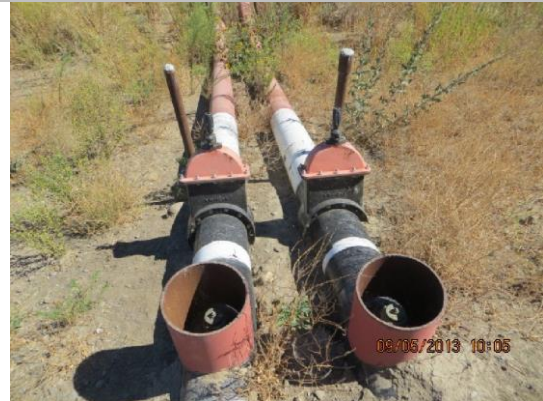
Photo 1 of 3 : UCIP_FA_2015_2461.jpg

Pipe, gate valve, and siphon breaker visible on WS slope.

Inspector Comments: FS_ID:22285
 DS_ID:24055
 EP_NO: N/A
 FS_HLM: 1.289
 Repair Type: Non-Urgent
 Crossing Status: Found
 UCIP Comments: No permit identified for this modified crossing.
 FIELD_STRUCT_DESC: 12-inch steel pipe through the levee 3-feet below the crown. Pump mounted on pile structure in ditch on the landward side. Siphon breaker in 12-inch steel riser unit and a gatevalve on the waterward shoulder. (Permit No. 8189, 1972)
 FS Date: 09/10/2013

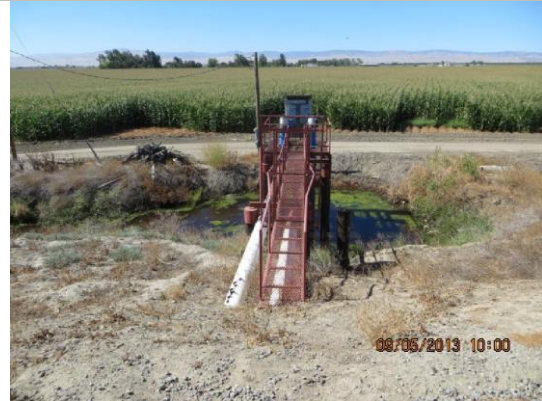
Photo 2 of 3 : UCIP_FA_2015_2462.jpg

Pipe, pump, and walkway visible on LS toe.

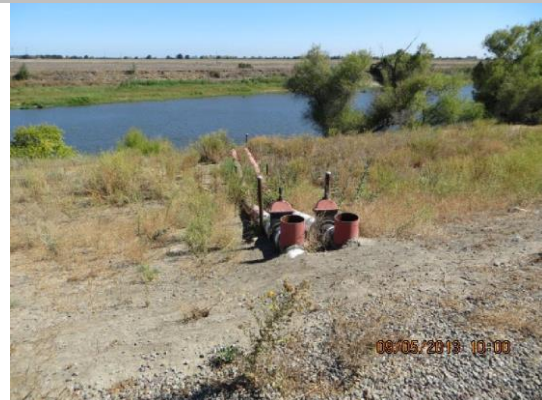
Photo 3 of 3 : UCIP_FA_2015_2463.jpg

Pipe, gate valve, and siphon breaker visible on WS slope.

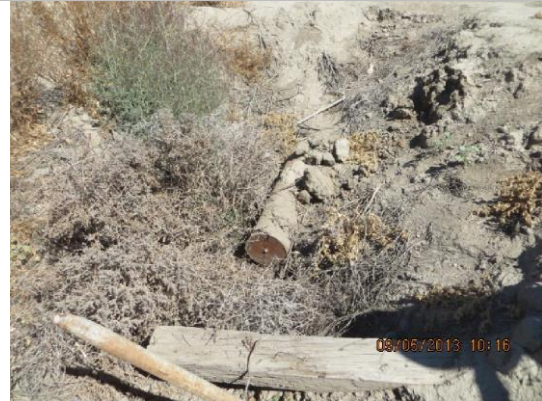
Photo 1 of 3 : UCIP_FA_2015_5735.jpg

LM Start	1.41	Rating **	M	Issue No.	57
LM End	1.41	Issue Type +	En	Location *	LS
Category	Supplemental			GPS Latitude/Longitude	
				Start	End
Item	DWR UCIP Field Study			37.714049 °	37.714049
				-121.288426 °	-121.288426
DWR ID					
Action/Comments					
Inspector Comments: FS_ID:41351					
DS_ID:20679					
EP_NO: 3975					
FS_HLM: 1.351					
Repair Type: Non-Urgent					
Crossing Status: Found

Pipe visible at bottom of ditch on LS toe.

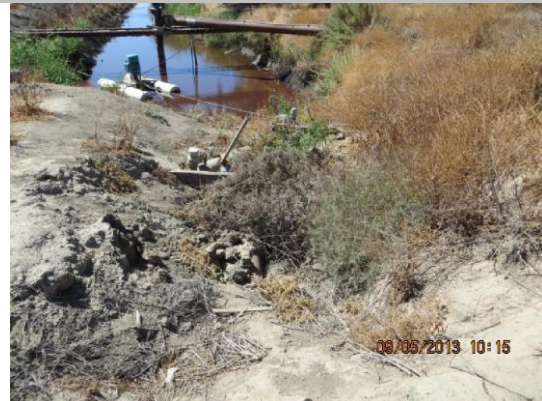
Photo 2 of 3 : UCIP_FA_2015_5736.jpg

Pipe visible at bottom of ditch on LS toe.

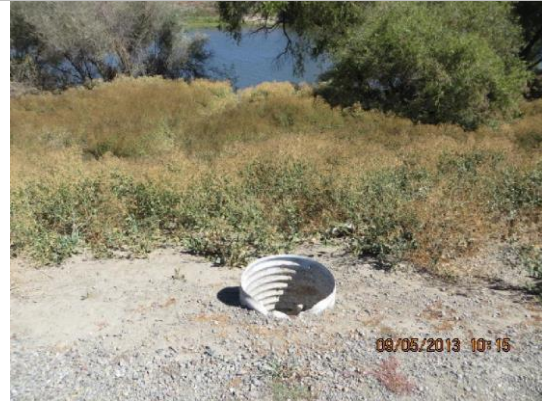
Photo 3 of 3 : UCIP_FA_2015_5737.jpg

Siphon breaker in 24-inch CMP riser on WS shoulder.

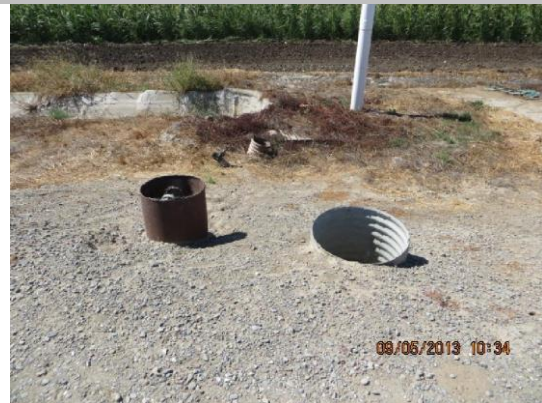
Photo 1 of 3 : UCIP_FA_2015_1167.jpg

LM Start	2.04	Rating **	M	Issue No.	58
LM End	2.04	Issue Type +	En	Location *	LS
Category	Supplemental			GPS Latitude/Longitude	
				Start	End
Item	DWR UCIP Field Study			37.708826 °	37.708826 °
				-121.279271 °	-121.279271 °
DWR ID					
Action/Comments					
Inspector Comments: FS_ID:19423 DS_ID:20681 EP_NO: N/A FS_HLM: 1.977 Repair Type: Non-Urgent Crossing Status: Found UCIP Comments: This pipe is abandoned and should be done so properly. FIELD_STRUCT_DESC: 1 of 2: 10-inch pipe through the levee 2.0-feet below the crown. Pump mounted on pile structure in the river. Siphon breaker in 24-inch CMP riser on the LS slope. Power pole on LS toe. Wooden stairs and walkway from the berm to the pump structure. Originally included in the 1968 O&M manual. FS Date: 09/05/2013

Siphon breaker in 24-inch CMP riser on LS slope. Possible gate valve at end of concrete channel on LS toe.

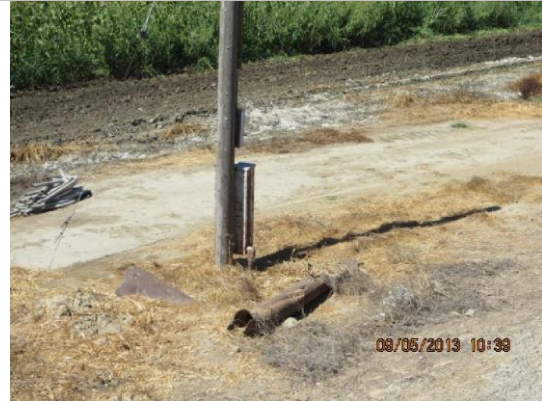
Photo 2 of 3 : UCIP_FA_2015_1562.jpg

Power pole on LS toe.

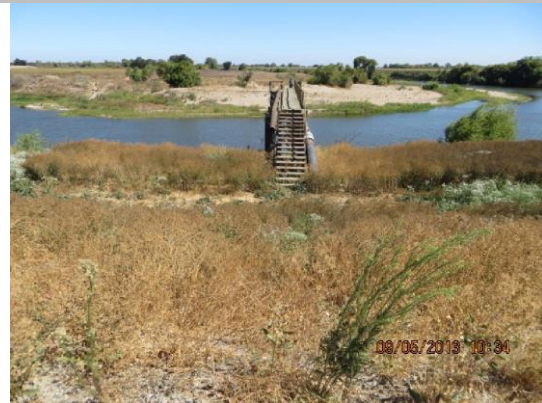
Photo 3 of 3 : UCIP_FA_2015_1563.jpg

Pipe cut at wooden pier. No pump on end of pier for this pipe.

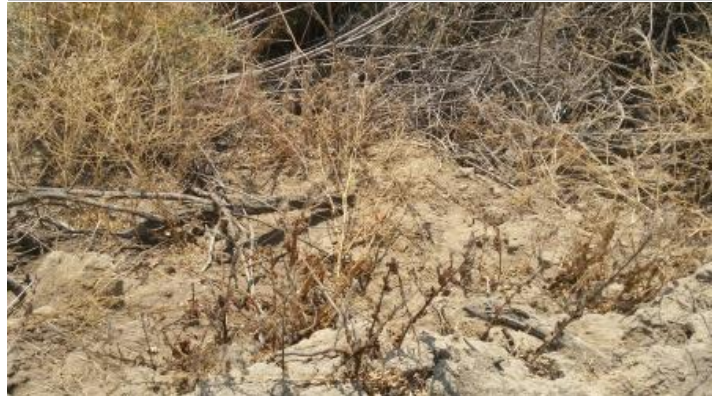
Photo 1 of 2 : SJR2015_RD2085U01RM66.50_11.jpg

121.274894 °	121.274894
DWR ID					
Action/Comments					
Inspector Comments: 09/10/2015: No significant change observed. Signs of animal activity are present. 09/10/2014: No significant change observed. 09/20/2013: No significant change in erosion observed. More vegetation at the site. 12/04/2012: The erosion has progressed remarkably toward levee, extended to the up-and downstream of the original pocket erosion. Trees and dense bush are present at the site. Animal burrow holes are visible, and possibly can cause seepage. 09/22/2010: No significant change observed. There is little visibility due to seasonal grass on the berm and slope. 08/18/2009: Site is located on berm; pocket erosion has developed; the site is covered in dense vegetation; there are several relief wells on the landside of the levee; site is Not Rated because berm width is greater than 30 feet; site should be monitored to keep track of erosion progress. [2015 Site ID:RD2085U01RM66.5]

Direct view of the erosion. Note dense vegetation at the site.

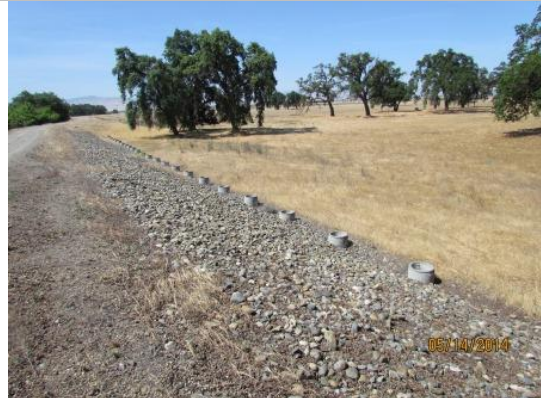
Photo 1 of 1 : FA_2015_RD2085_113_20_20150910_00005.jpg

LM Start	2.58	Rating **	A/W	Issue No.	20
LM End	2.58	Issue Type +	Ob	Location *	LS
Category	Earthen Levee			GPS Latitude/Longitude	
				Start	End
Item	Underseepage Relief Wells			37.702903 °	37.702903 °
				-121.274860 °	-121.274860 °
DWR ID	DWR_RD2085_01_s_2012_20				
Action/Comments

View of the underseepage relief wells at the landside levee toe.

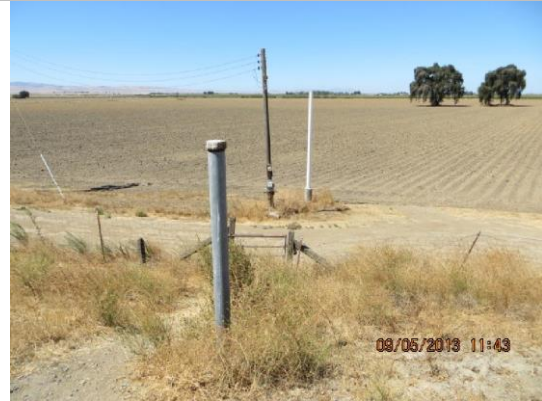
Photo 1 of 3 : UCIP_FA_2015_1840.jpg

Inspector Comments: FS_ID:19431
DS_ID:20688
EP_NO: 16970
FS_HLM: 2.746
Repair Type: Non-Urgent
Crossing Status: Found
UCIP Comments: The wooden walkway on the WS slope is in disrepair.
FIELD_STRUCT_DESC: 1 of 2: 14-inch steel irrigation pipe through the levee 2.0 feet below the crown. Pump on wooden pier at WS slope.
Siphon breaker visible next to steel bollard on LS slope. Power pole on LS toe.
FS Date: 09/05/2013

Power pole on LS toe with possible PVC riser.

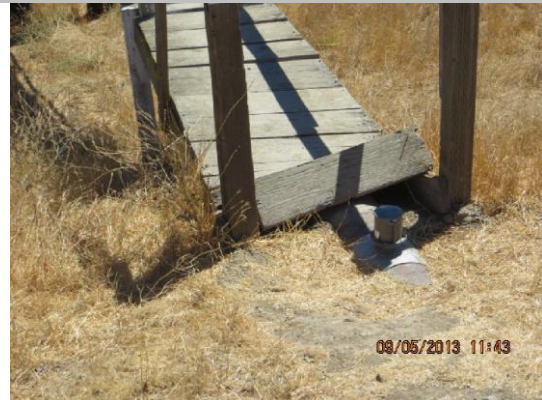
Photo 2 of 3 : UCIP_FA_2015_1841.jpg

Pipe visible under walkway on WS slope.

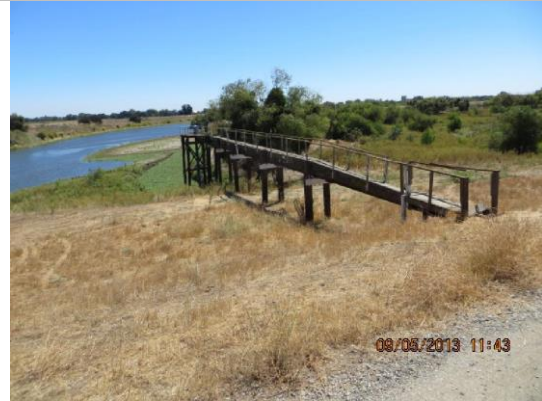
Photo 3 of 3 : UCIP_FA_2015_1842.jpg

Pump on Wooden pier at WS slopoe.

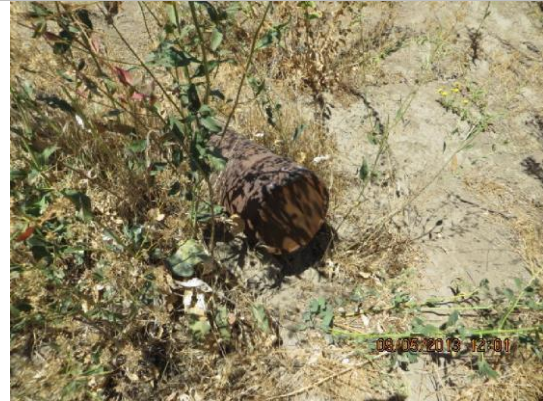
Photo 1 of 3 : UCIP_FA_2015_1843.jpg

Inspector Comments: FS_ID:19433
 DS_ID:20693
 EP_NO: N/A
 FS_HLM: 3.227
 Repair Type: Non-Urgent
 Crossing Status: Found
 UCIP Comments: Pipe appears abandoned and should be done so properly.
 FIELD_STRUCT_DESC: 10-inch steel stormdrain pipe through the levee 4.0-feet below the crown. T-post marks location of Pipe at LS toe. Steel plate welded over pipe on WS slope. Asbuilts available DWG 7-4-1685. Originally included in the 1968 O&M manual.
 FS Date: 09/05/2013

Pipe visible on WS slope. Steel plate welded over end.

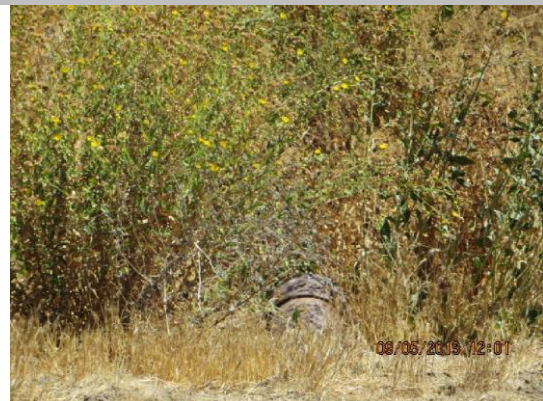
Photo 2 of 3 : UCIP_FA_2015_1844.jpg

Pipe visible on WS slope.

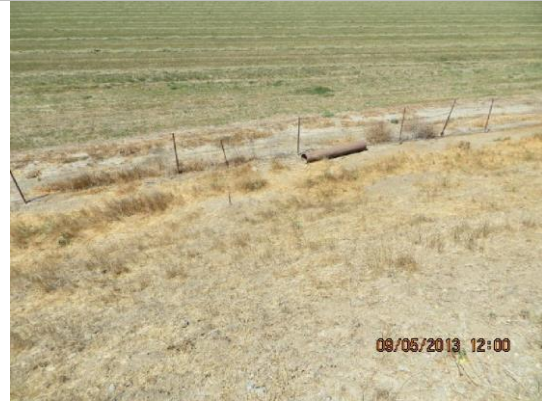
Photo 3 of 3 : UCIP_FA_2015_1845.jpg

T-post marking pipe end on LS toe. 10-inch pipe debris on LS toe.

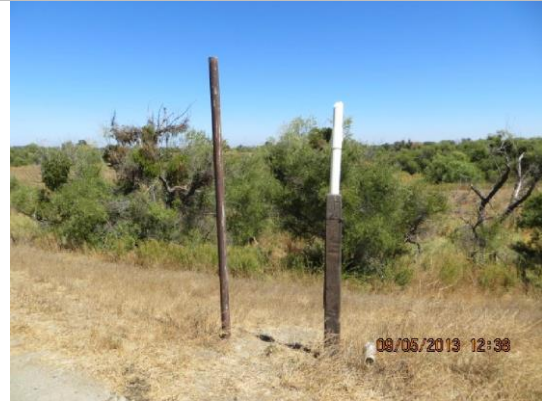
Photo 1 of 3 : UCIP_FA_2015_1846.jpg

Inspector Comments: FS_ID:19435
 DS_ID:20687
 EP_NO: 16970
 FS_HLM: 3.343
 Repair Type: Non-Urgent
 Crossing Status: Found
 UCIP Comments: Appears abandoned and if so should be done so properly.
 FIELD_STRUCT_DESC: 2 of 2: 10-inch steel stormdrain pipe through the levee 2-feet below the crown. Appears to connect to pump 150-feet off LS toe. Possible butterfly valve at LS toe. Vent on WS shoulder. Steel plate welded over pipe end on WS toe.
 FS Date: 09/05/2013

Vent on WS shoulder.

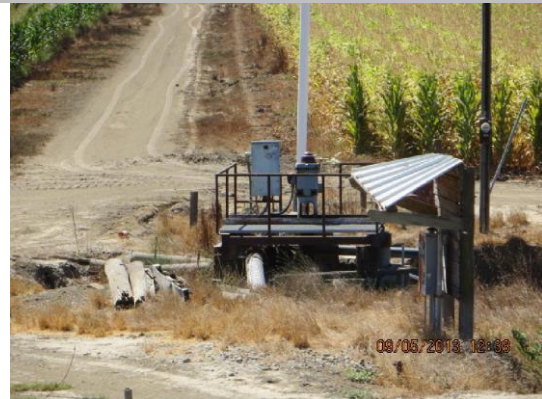
Photo 2 of 3 : UCIP_FA_2015_1847.jpg

Possible connection at pump 150-feet off LS toe.

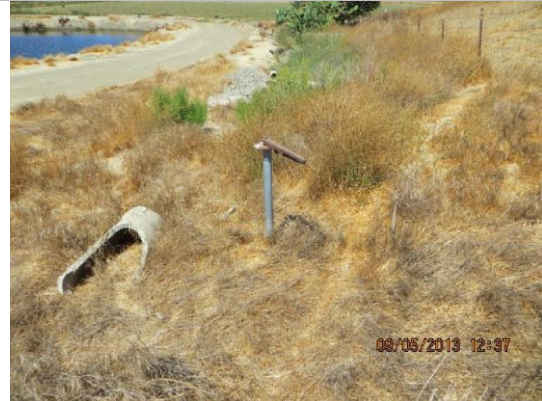
Photo 3 of 3 : UCIP_FA_2015_1848.jpg

Possible Butterfly valve at LS toe.

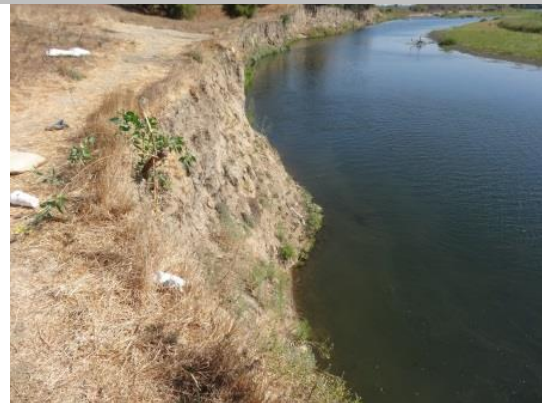
Photo 1 of 2 : SJR2015_RD2085U01RM67.70_4.jpg

LM Start	3.62	Rating **	A/W	Issue No.	2
LM End	3.75	Issue Type +	Ma	Location *	WS
Category	Supplemental			GPS Latitude/Longitude	
				Start	End
Item	DWR Erosion Survey			37.688545 °	37.688545 °
				-121.276298 °	-121.276298 °
DWR ID					
Action/Comments					
Inspector Comments: 08/19/2015: No significant change observed. 7/17/2014: No significant change observed. 09/10/2013: No significant change observed. 12/04/2012: This site has been documented before, and a cost estimate to repair has been prepared dated 05/09/2010. The fresh cut shows the erosion is developing. The berm width is at least 42 feet. Sticks were placed at three locations along the river bank, with 3 sticks 5 feet apart at each location. [2015 Site ID:RD2085U01RM67.7]

Close view of the erosion.

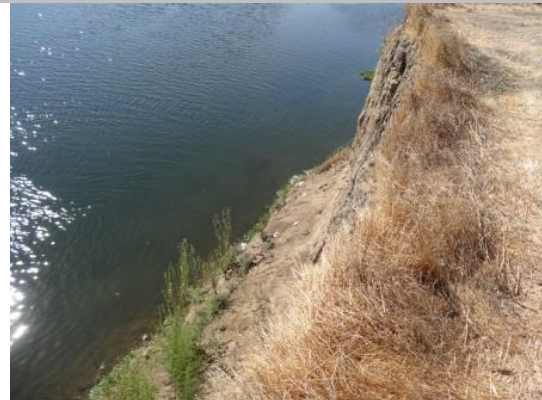
Photo 2 of 2 : SJR2015_RD2085U01RM67.70_9.jpg

Direct view of the erosion.

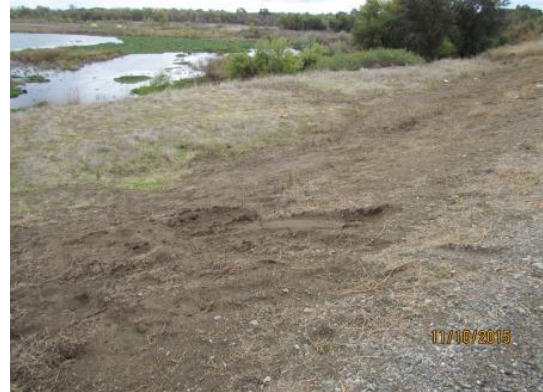
Photo 1 of 1 : FA_2015_RD2085_113_25_20151112_00020.jpg

LM Start	3.71	Rating **	M	Issue No.	25
LM End	3.71	Issue Type +	Ma	Location *	WS
Category	Earthen Levee			GPS Latitude/Longitude	
				Start	End
Item	Slope Stability			37.688216 °	37.688216 °
				-121.276603 °	-121.276603 °
DWR ID	DWR_RD2085_01_f_2015_25				
Action/Comments					
Repair the levee slope damaged by vehicle traffic and prevent access where possible.

View of the waterside levee slope damaged by vehicle.

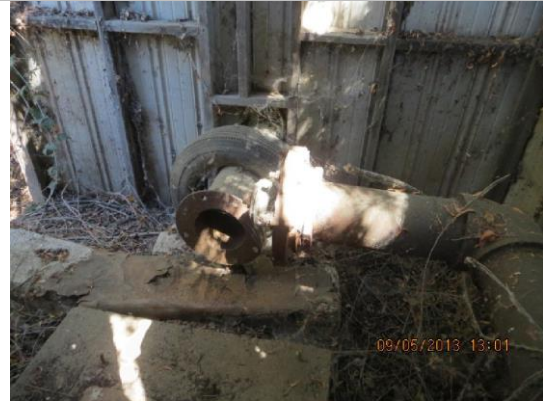
Photo 1 of 3 : UCIP_FA_2015_1938.jpg

Inspector Comments: FS_ID:19443
 DS_ID:20684
 EP_NO: N/A
 FS_HLM: 3.955
 Repair Type: Non-Urgent
 Crossing Status: Found
 UCIP Comments: This pipe appears abandoned and should be done so properly.
 FIELD_STRUCT_DESC: 6-inch steel irrigation pipe through the levee 4.0-feet below the crown. Pump house on the waterward berm. Siphon breaker in 24-inch corrugated metal riser unit on the landside shoulder. Vent on WS toe. 2-inch galvanized iron electrical conduit at same location. Originally included in the 1968 O&M manual.
 FS Date: 09/05/2013

Pump missing from pipe in pumphouse on WS toe.

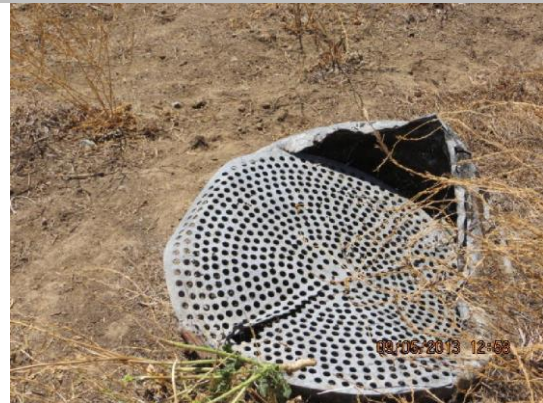
Photo 2 of 3 : UCIP_FA_2015_1939.jpg

Siphon breaker on vent in 24-inch CMP riser on LS shoulder.

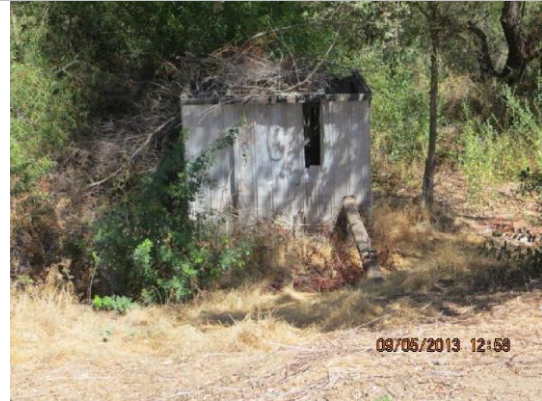
Photo 3 of 3 : UCIP_FA_2015_1940.jpg

Pumphouse and pipe visible on WS toe.

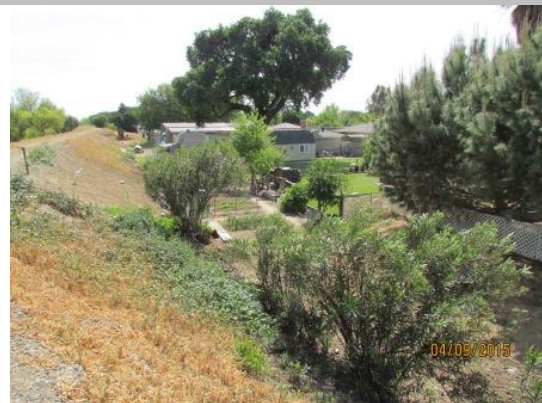
Photo 1 of 2 : FA_2015_RD2085_113_33_20150910_00007.jpg

LM Start	4.26	Rating **	C	Issue No.	54
LM End	4.53	Issue Type +	Ma	Location *	WS
Category	Earthen Levee			GPS Latitude/Longitude	
				Start	End
Item	Vegetation			37.681886 °	37.681332 °
				-121.272333 °	-121.267518 °
DWR ID	DWR_RD2085_01_s _ 2012_54				
Action/Comments					
Remove the wild growth other than native grasses from the levee slopes.

View of the landscaping at the landside levee slope.

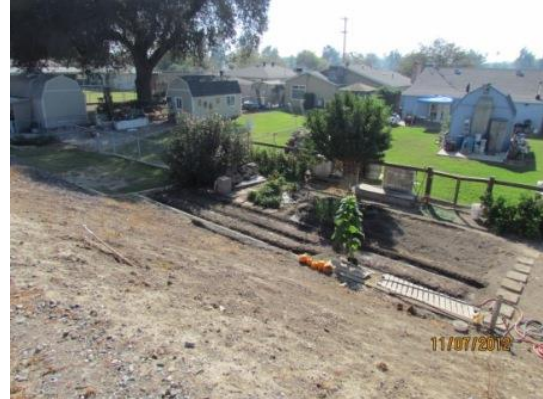
Photo 2 of 2 : FA_2015_RD2085_113_33_20150910_00008.jpg

Updated photo of encroachments on landside toe.

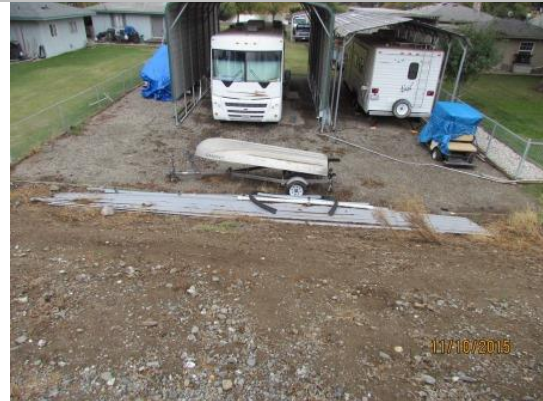
Photo 1 of 1 : FA_2015_RD2085_113_27_20151112_00021.jpg

LM Start	4.43	Rating **	M	Issue No.	27
LM End	4.43	Issue Type +	En	Location *	LS
Category	Earthen Levee			GPS Latitude/Longitude	
				Start	End
Item	Encroachments			37.681710 °	37.681710 °
				-121.269290 °	-121.269290 °
DWR ID	DWR_RD2085_01_f_2015_27				
Action/Comments					
Material

View of the material stored at the landside levee toe.

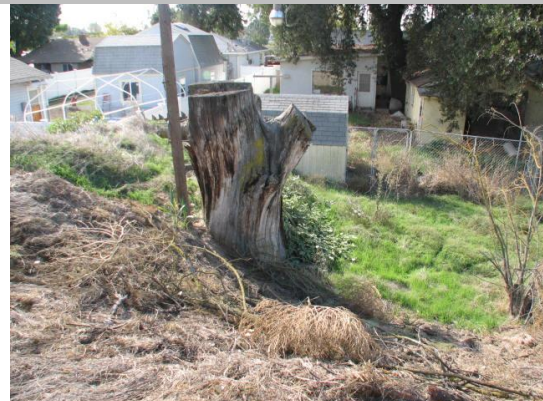
Photo 1 of 1 : FA_2015_RD2085_113_32_20150910_00006.jpg

LM Start	4.46	Rating **	N	Issue No.	32
LM End	4.46	Issue Type +	Ma	Location *	LS
Category	Earthen Levee			GPS Latitude/Longitude	
				Start	End
Item	Trim / Thin Trees			37.681605 °	37.681605 °
				-121.268882 °	-121.268882 °
DWR ID	DWR_RD2085_01_s_2012_32				
Action/Comments					
Tree stumps.

11/03/2011 Large stump on landside slope.

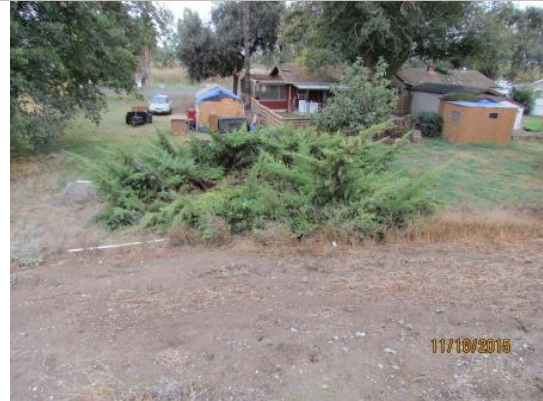
Photo 1 of 1 : FA_2015_RD2085_113_28_20151112_00022.jpg

View of the unmaintained vegetation at the landside levee toe.

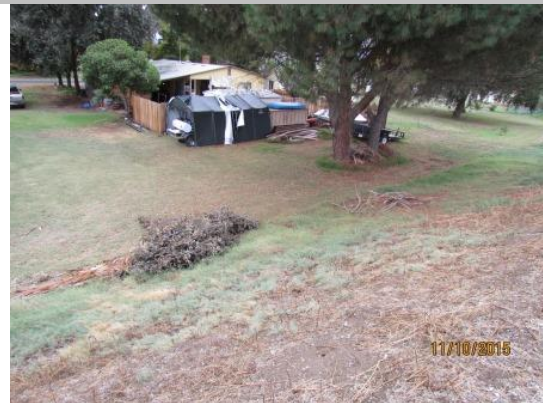
Photo 1 of 1 : FA_2015_RD2085_113_17_20151112_00023.jpg

View of the firewood stored at the landside levee toe.

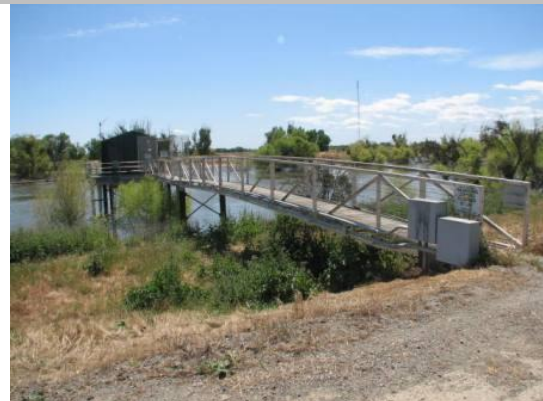
Photo 1 of 1 : FA_2015_RD2085_113_36_20150910_00010.jpg

04/28/2011 Monitoring station.

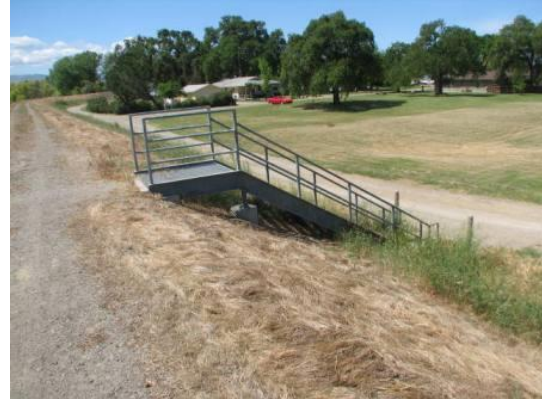
Photo 1 of 1 : FA_2015_RD2085_113_35_20150910_00009.jpg

04/28/2011 Stairs on landside slope for monitoring station.

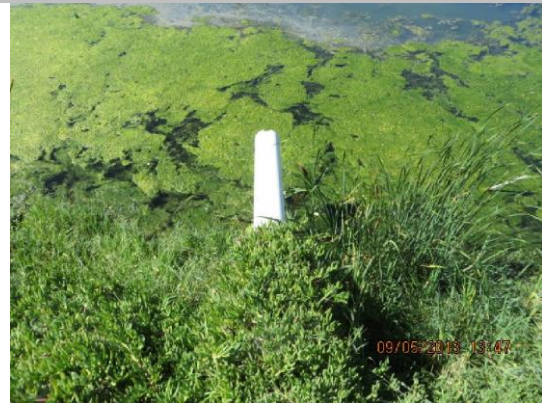
Photo 1 of 3 : UCIP_FA_2015_2453.jpg

LM Start	5.23	Rating **	M	Issue No.	63
LM End	5.23	Issue Type +	En	Location *	LS
Category	Supplemental			GPS Latitude/Longitude	
				Start	End
Item	DWR UCIP Field Study			37.675244 °	37.675244 °
				-121.269287 °	-121.269287 °
DWR ID					
Action/Comments					
Inspector Comments: FS_ID:22290 DS_ID:24058 EP_NO: N/A FS_HLM: 5.14 Repair Type: Non-Urgent Crossing Status: Found UCIP Comments: No permit identified for this crossing. FIELD_STRUCT_DESC: 10-inch steel irrigation pipe through the levee at unknown depth below the crown. Siphon breaker in 10-inch steel riser on LS shoulder. FS Date: 09/10/2013

Pipe visible at pond outlet off LS toe.

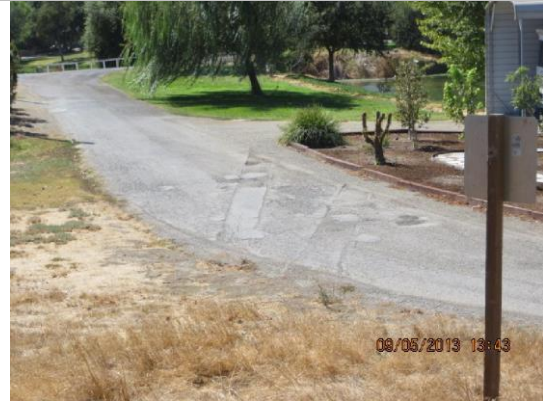
Photo 2 of 3 : UCIP_FA_2015_2454.jpg

Cuts in pavement may indicate alignment of pipe at LS toe.

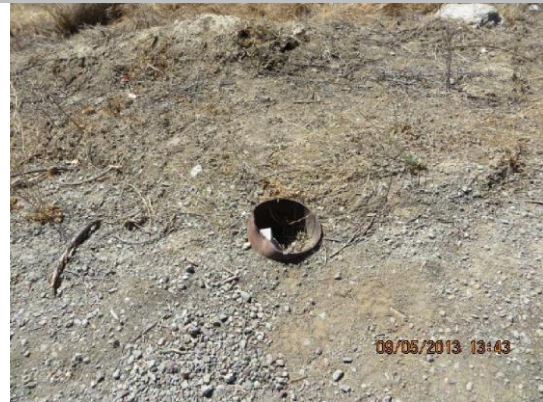
Photo 3 of 3 : UCIP_FA_2015_2455.jpg

Siphon breaker in 10-inch steel riser on LS shoulder.

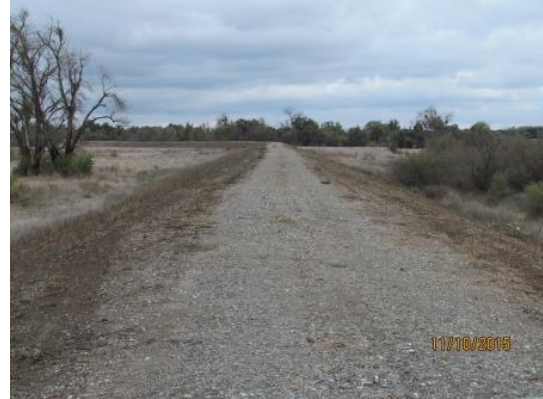
Photo 1 of 1 : FA_2015_RD2085_115_4_20151112_00003.jpg

View of the acceptable vegetation control on the waterside levee slope.

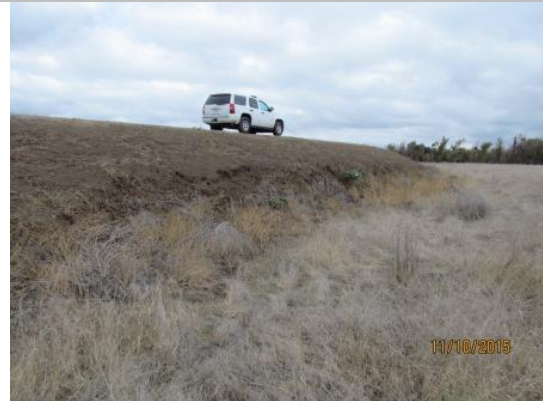
Photo 1 of 1 : FA_2015_RD2085_115_1_20151112_00004.jpg

View of the erosion at the waterside levee toe.
